# 16 PRESERVATION BRIEFS

## The Use of Substitute Materials on Historic Building Exteriors

National Park Service  
U.S. Department of the Interior  
Technical Preservation Services

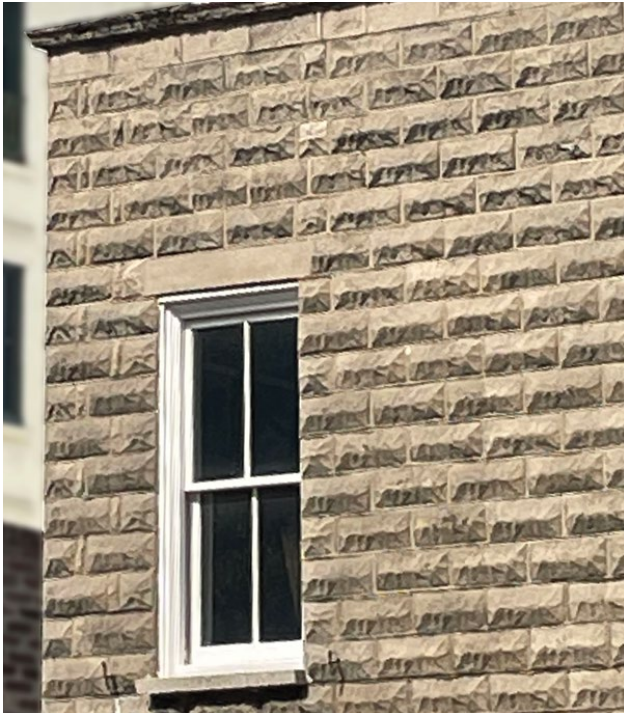
*Figure 2a: Casting concrete blocks to mimic quarried stone was a popular late 19th- to mid 20th-century technique. Concrete masonry units could be completed by local craftsman, saving time and shipping costs. Photo: John Sandor, NPS.*

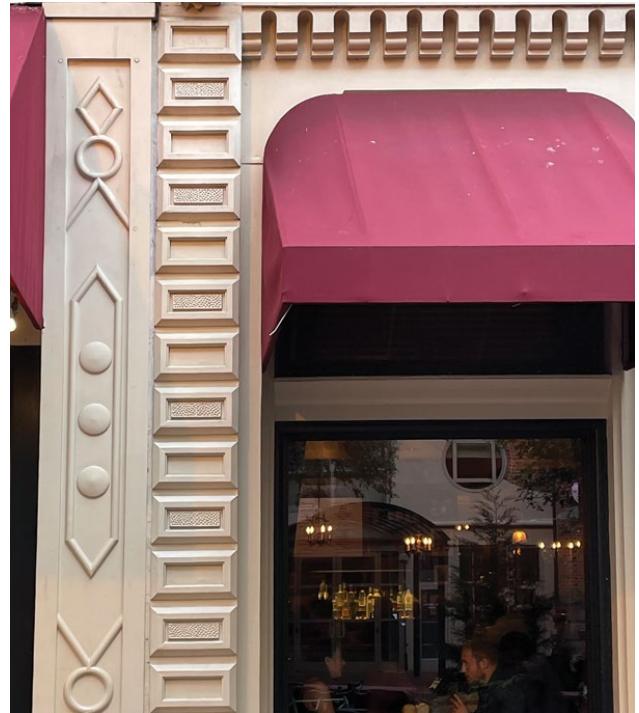
*Figure 2b: The 19th century also produced a variety of metal products used to imitate other materials. Across the country, cast iron was used in storefronts to imitate stone. Photo: John Sandor, NPS.*

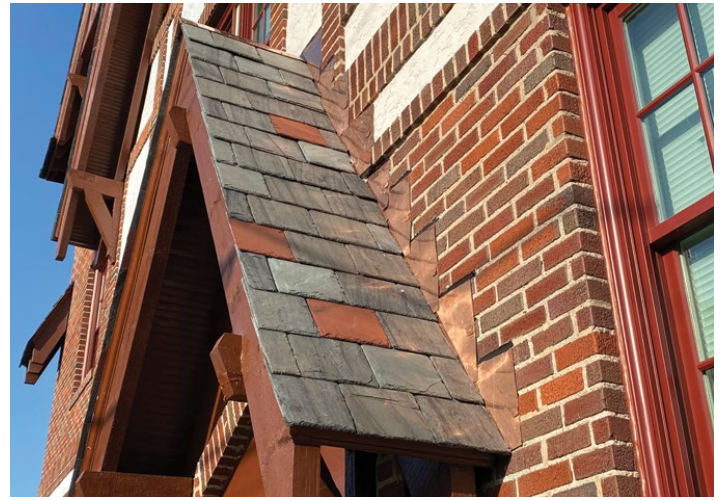
Figure 5. (Left) Asbestos shingles were often used as a substitute for traditional slate roof shingles. The historic asbestos roof on this rehabilitation project had reached the end of its lifespan and required complete replacement. (Right) Given the limited replacement materials available to match the historic asbestos shingles, utilizing natural slate was determined to be the best visual match for the original shingles and design intent in this instance. Photos: Crosskey Architects.

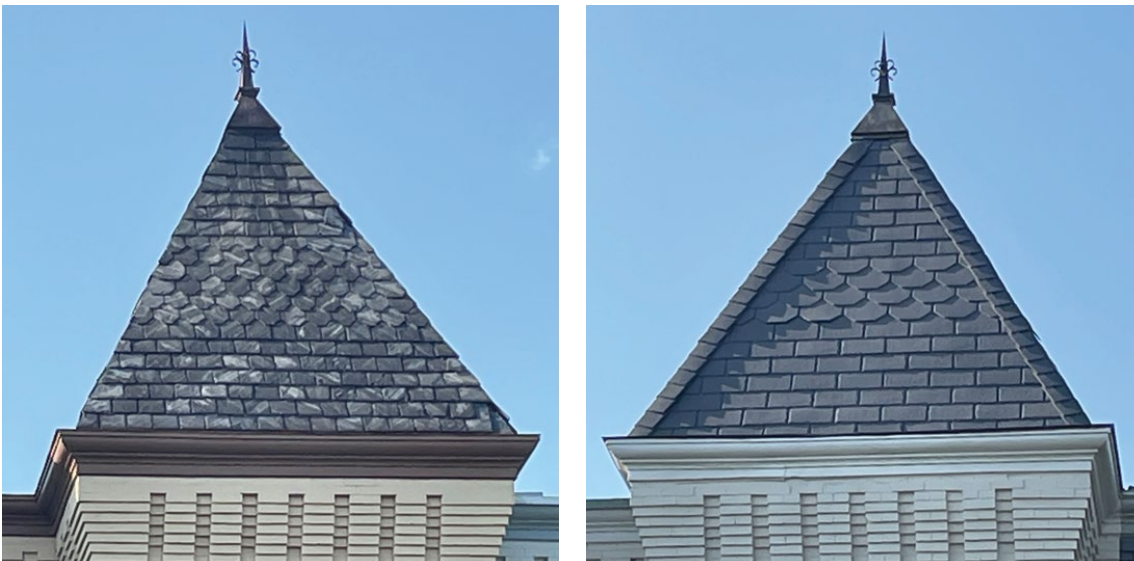
*Figure 10. Polymer slates offer a choice of shapes but not sizes, limiting their ability to achieve a good visual match for some historic slate. With the size of the polymer slates (right) being nearly twice that of the historic slates (left), the scale of the entire feature is incompatibly altered. The molded edges of this material, which contribute to its ability to replicate slate, would be lost if each shingle was resized by cutting. Photo: John Sandor, NPS.*
