7 Preservation Briefs

The Preservation of Historic Glazed Architectural Terra-Cotta

de Teel Patterson Tiller

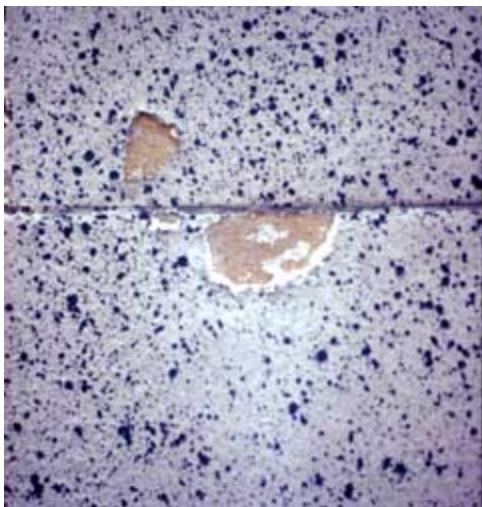
Blistering of the glaze, like crazing, is the result of the increase in water in the porous clay body and the subsequent destruction of the glaze as a result of water migration and pressure. Glaze spalling may also be caused by deterioration of metal anchors behind the terra-cotta unit. Photo: NPS files.

Glaze spalling (left) may appear as small coin-size blisters where the glaze has ruptured and exposed the porous tile body beneath. This may occur as several spots on the surface or, in more advanced cases of deterioration, it may result in the wholesale disappearance of the glaze. Spalling of the glaze may also be symptomatic of deterioration (rusting) of the internal metal anchoring system which holds the terra-cotta units together and to the larger building structure. The increase in volume of the metal created by rusting creates increased internal pressures in the terra-cotta unit which, in turn, may spall the glaze, or in more extreme cases, cause material spalling.

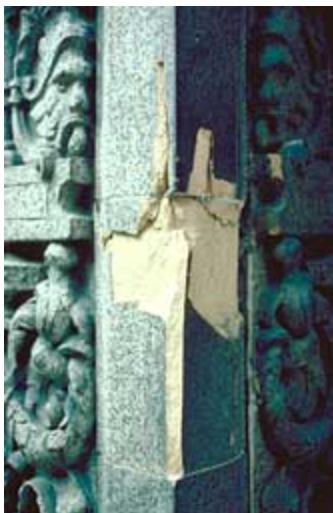
The damage shown here is the result of direct live load on a mid-rise building. The steel frame has settled and shifted the weight onto the exterior terra-cotta cladding, resulting in rupturing of the material. Photo: NPS files.

The development of large stress-related cracks or wholesale material deterioration is often caused by unaccommodated building-frame shortening under load, thermal expansion and contraction of the facade and moisture expansion of the glazed architectural terra-cotta units themselves. Cracks running through many units or stories or large areas of material deterioration often indicate stress-related problems. This sort of deterioration, in turn, permits significant water entry into the terra-cotta system.

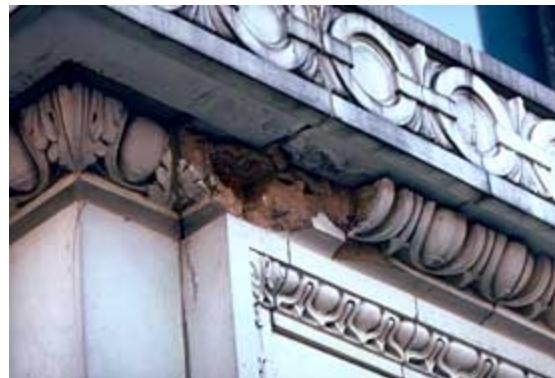
Material spalling is the result of excessive expansion of the porous tile body caused by water and freezing temperatures. This is a

consuming, and only in the experimental stage at this writing. These all generally preclude the use of anyone but an experienced professional. **serious condition, often difficult to repair.**
Photo: NPS files.

Material spalling is a particularly severe situation. Not only is the visual integrity of the detailing impaired, but a large area of the porous underbody, webbing and metal anchoring is exposed to the destructive effects of further water entry and deterioration. Both glaze and material spalling must be dealt with as soon as possible. Missing units is a serious situation which particularly plagues architectural terra-cotta systems. Unlike brick or stone, damaged glazed architectural terra-cotta is exceedingly difficult to replace. New production is extremely limited. Missing units create gaps which increase the structural load on the remaining pieces and also permit water to enter the system. Exposed or freestanding glazed architectural terra-cotta detailing (balusters, urns, parapet walls, etc.) are particularly susceptible to extensive loss of material.

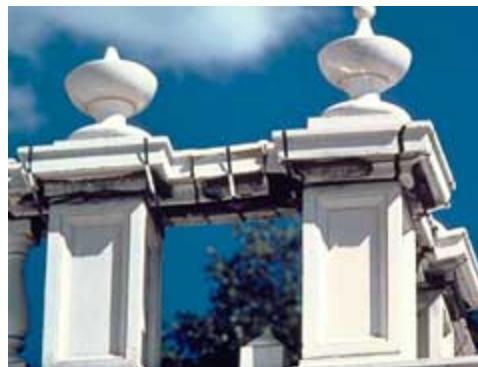
Exposed or freestanding terra-cotta detailing (parapets, urns, balusters, etc.) have traditionally been subjected to the most severe vicissitudes of deterioration as a result of freezing temperatures and water. Photo: NPS files.

These elements face the most severe vicissitudes of water and temperature-related deterioration in direct proportion to the extent of their exposure. The replacement of missing units should be a high priority work item in the rehabilitation of glazed architectural terra-cotta.

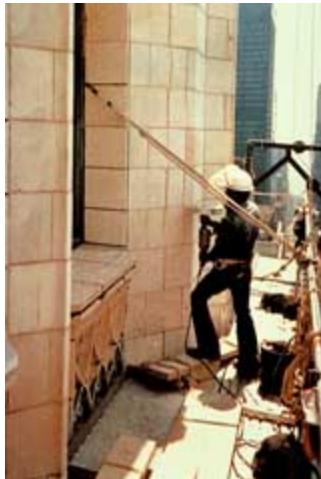
A worker cleans out mortar joints in preparation for repointing the architectural terra-cotta Photo: NPS files.

Repointing: Repointing of mortar which is severely deteriorated or improperly or infrequently maintained is one of the most useful preservation activities that can be performed on historic glazed architectural terra-cotta buildings. Ongoing and cyclical repointing guarantees the long life of this material. Repointing should always be carried out with a mortar which has a compressive strength (measured in p.s.i.) *lower* than the adjacent masonry unit. Hard (Portland cement) or coarsely screened mortars may cause point loading and/or prevent the outward migration of the water through the mortar joints, both of which ultimately damage the terra-cotta unit. Repointing with waterproof caulking compounds or similar waterproof materials should never be undertaken because, like waterproof coatings, they impede the normal outward migration of moisture through the masonry joints. Moisture then may build sufficient pressure behind the waterproof caulk and the glaze on the terra-cotta to cause damage to the unit itself.

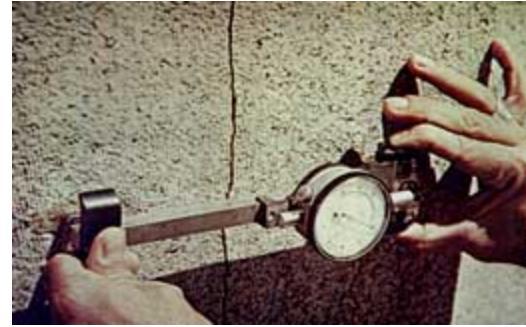
This crack is being measured. Structural cracking, whether static (nonmoving) or dynamic (moving) should be caulked to prevent water entry into the glazed architectural terra-cotta system. Photo: NPS files.

Holes, sign anchors, slots for channel steel, or structural cracking in the surface of glazed architectural terra-cotta cladding should be permanently sealed with a material that will expand with the normal dynamics of the surrounding material, yet effectively keep water out of the system. Any one of a number of commercially available waterproof caulking compounds would be appropriate for this work. Holes and static (non-moving) cracks may be caulked with butyl sealants or acrylic latex caulk. For dynamic (moving or active) cracks, the polysulfide caulk are most often used, although others may be safely employed. It is, however, important to remember that these waterproof caulking compounds are not viable repointing materials and should not be used as such.
